# Town of Arlington

## FINAL REPORT

### ADA Self-Evaluation (as basis for Transition Plan)

Prepared by  
Institute for Human Centered Design  
December 15, 2014

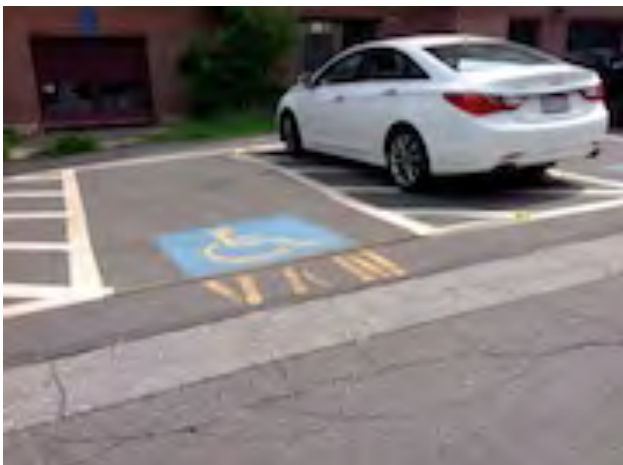
Photo 6

Although there are the required number of van and standard accessible parking spaces provided, they do not measure up to the individual space requirements, nor does the total width for this configuration measure up to the minimal total space required. (Photo 6)

Best practice recommendation: provide access aisle on passenger side of accessible van.

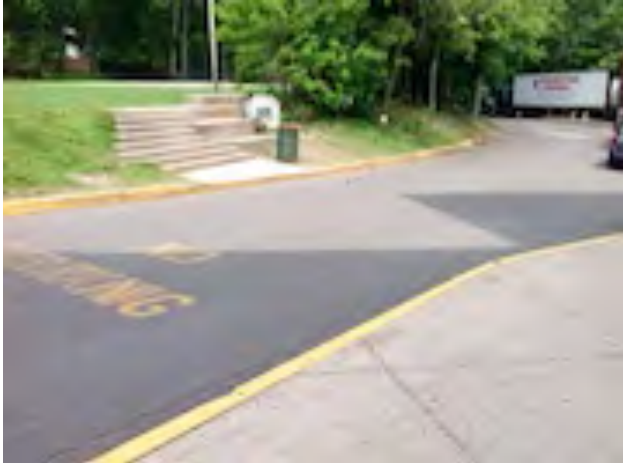
Photo 7

The stairway opposite the school entrance is not adjoining an access route or any sidewalk; and is in disrepair. There is no matching accessible ramp provided. (Photo 7)

2, Repair staircase and add accessible handrails and a level top landing.

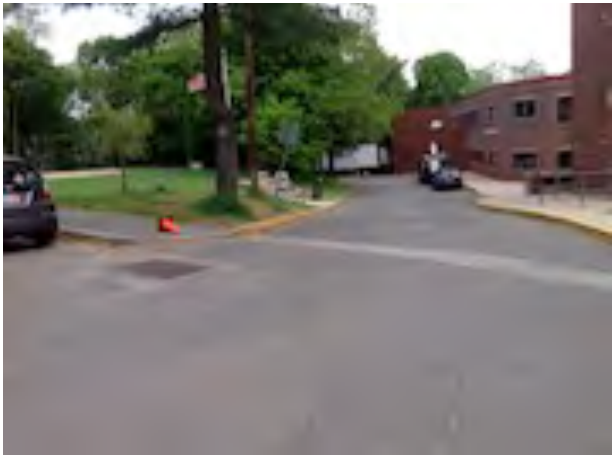
Photo 8

The entry to field from accessible parking spaces includes a curb at the corner followed by a paved path with excessive cross and run slopes. (Photo 8)

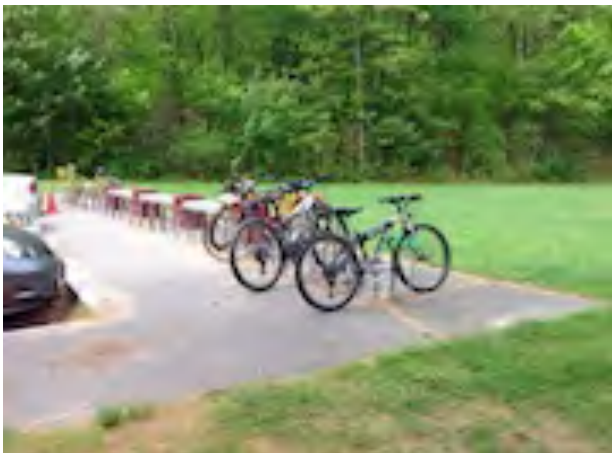
Photo 9

This walkway has an uneven surface, excessive cross and run slopes, and has a bike rack located at the side that is closest to the accessible parking spaces, obstructing the general public's path of travel onto the field from the parking lot. (Photo 9)

This walkway does not connect to at least one accessible interior walkway that provides a firm, level, smooth (non-grassy) continuous route connecting to the perimeter of the field playing areas, the dugout areas, team seating locations, the portable toilet, and the spectator seating along the fence.

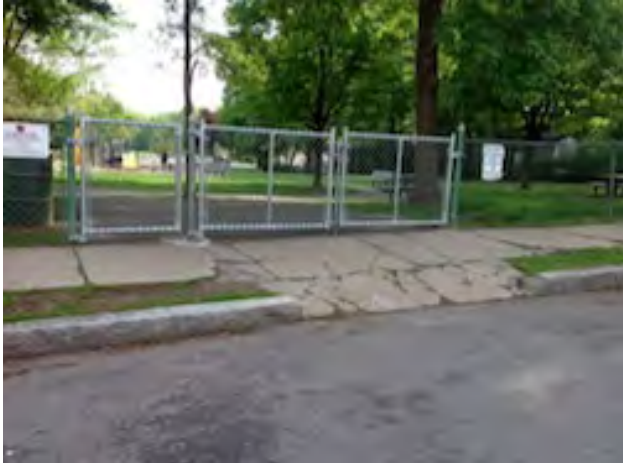
Photo 4

Entrance has 2 fences. Sidewalk apron is cracked and uneven and sidewalk pavement has excessive cross slopes. The entrance needs maintenance. (Photo 4)

Repair cracked sidewalk panels at entry gate.

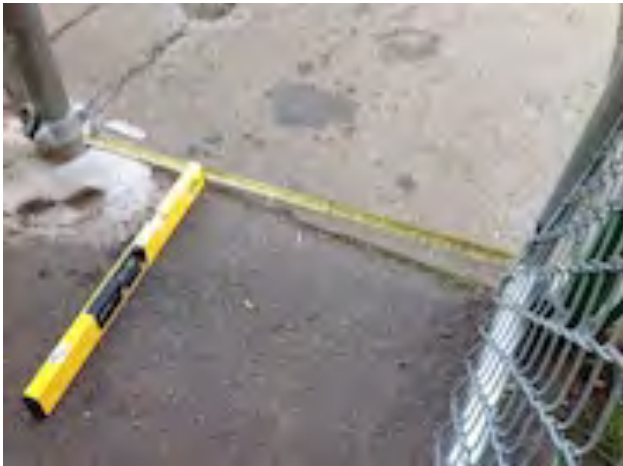
Photo 5

Ground surface under the narrower gate is uneven and needs maintenance. (Photo 5)

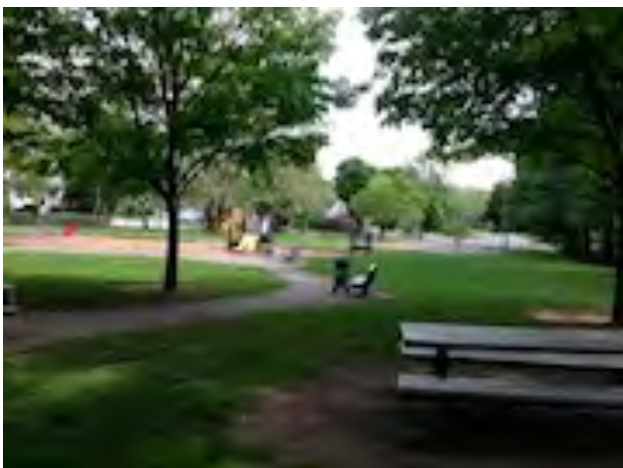
Photo 6

Walkways circulate through the park and around the play areas. The walkways are well graded, smooth and have compliant widths. However, they do not provide a route to all the park features, such as an accessible approach and entry into the play areas, to either side of the court, and to the benches and picnic tables. (Photo 6)

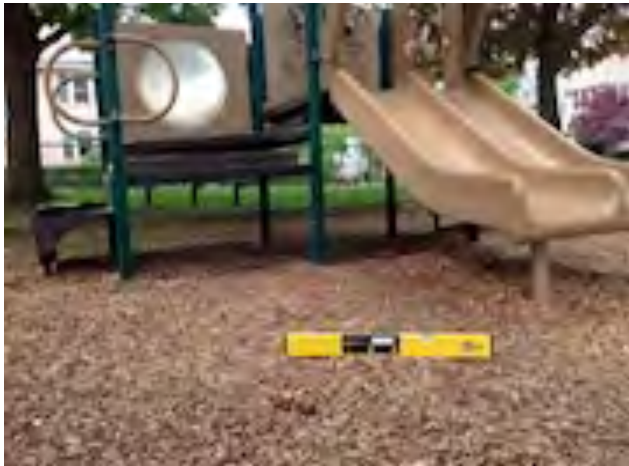
Photo 8

The loose fill ground surface that covers the play areas will require frequent maintenance to ensure an accessible route to all entry/exit points of accessible play components.

At this time, the loose fill materials are showing excessive cross slopes and holes. These uneven conditions prevent smooth, accessible and unrestricted circulation around the play structures. (Photo 8)

a. If only loose fill ground surface materials are used, a high-frequency maintenance policy needs to be in place to ensure accessibility of ground surface materials in play area use zones through all seasons.

b. If ground surface materials will be replaced: consider adding unitary ground surface materials within the playground areas to provide accessible routes and clear ground spaces to all entry/exit points of ground play elements, including swingsets, spring rockers and play structure.

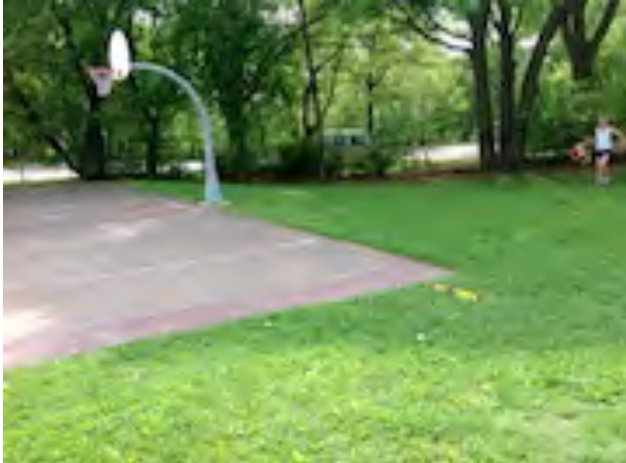
Photo 10

A basketball court is not connected by accessible route to the other areas and elements of the facility, including the entrance. (Photo 10)

Slope measurements taken to one side of the court indicate that it may be feasible to add a graded walkway connecting at least one side of the court to the play area, circulation routes, benches and tables, and entrance gate.

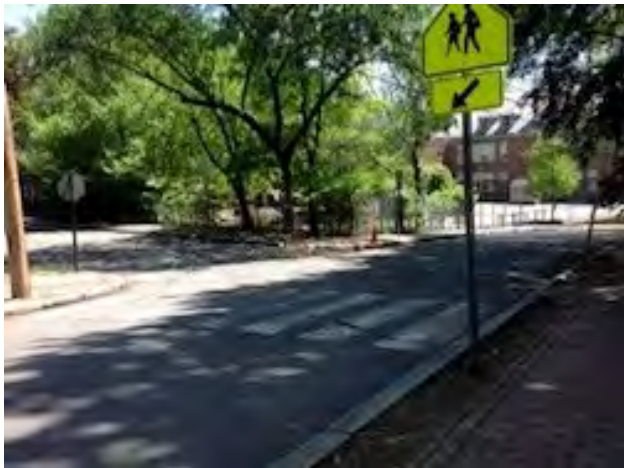
Photo 2

Crosswalk at Irving and Academy St. is highly inaccessible with steep slopes. The Pedestrian Safe Crossing sign is mounted on an unsafe, not smooth completely inaccessible brick sidewalk. There is no curb ramp at either end of the crosswalk. On the school side, the curb cut is unusable, with no flared sides, no accessible slopes, and no bottom landing. (Photo 2)

When street reconstruction is planned for Irving St., replace brick sidewalk on SW side with smooth surface panels, such as concrete or asphalt, which, if constructed correctly, can be maintained as accessible for the life of the build.

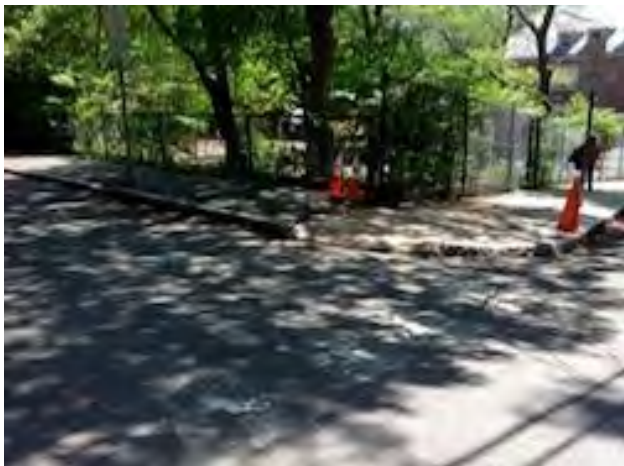
Photo 3

Curb ramps at Academy St. and Irving are either missing, in disrepair, or, where provided, are incorrectly constructed with steep slopes and lack of bottom and top landings. (Photo 3)

These issues negatively impact the provision of an accessible route connecting facility to site arrival points, including the nearby public transit stop at Pleasant @ Irving St. and the adjacent streets and sidewalks.

Reconstruct sidewalks and curb ramps from Public transit stop to intersection of Pleasant & Irving St. At curb ramp nearest APS pole, replace apex curb ramp with blended curb ramp oriented towards east.

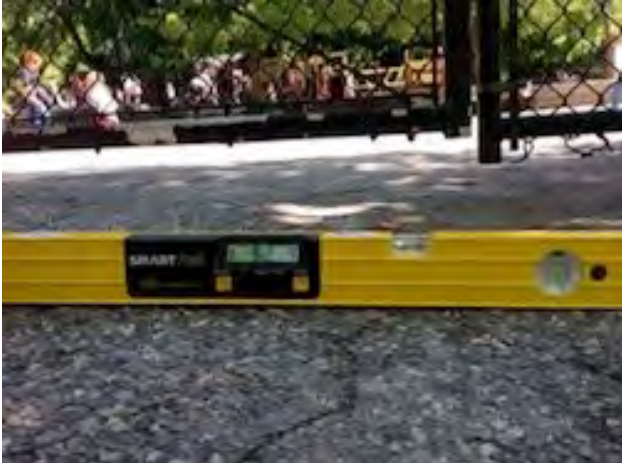
Photo 4

Sidewalks from Pleasant St. & Irving to facility have excessive cross slopes. and require repair around the perimeter of facility. (Photo 4)

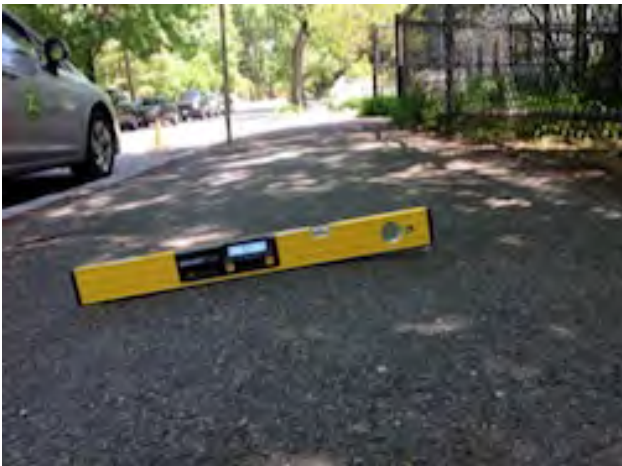
Photo 5

Sidewalks along Academy Street do not have topological constrains and need to be mitigated to provide accessible walkway slopes. The cross slopes near the Academy St. gate exceed 8% in places, where the maximum should not be more than 2.08%. (Photo 5)

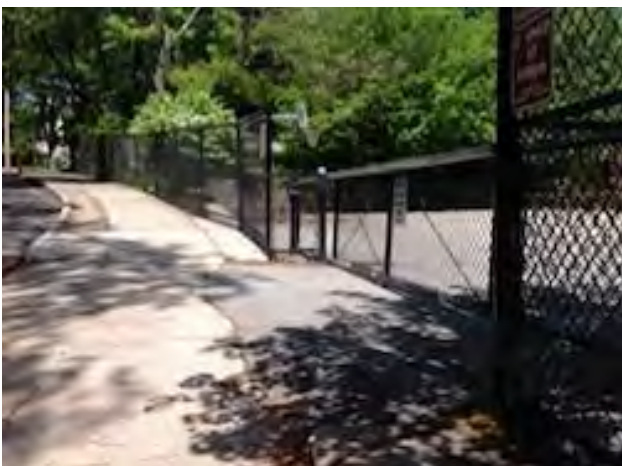
Photo 6

Both points of entry have excessive cross slopes. The sidewalk and entry panels near the gate are in disrepair. (Photo 6)

1. Replace driveway apron at Irving St. entrance with sidewalk that blends to 5% at entrance within pedestrian zone. Repair cracks in asphalt and ensure that ground materials match levels. (about 4 S.F.)

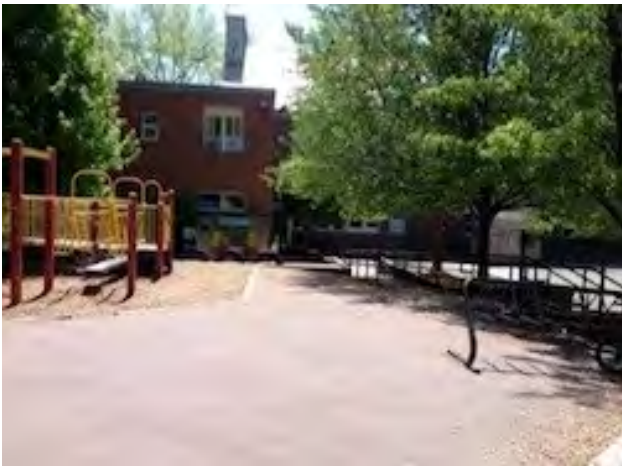
*Photo 8*

Walkways do not connect with play areas because the borders surrounding play areas is not level with either the loose fill in the play areas and the walkway hardtop. (Photo 8)

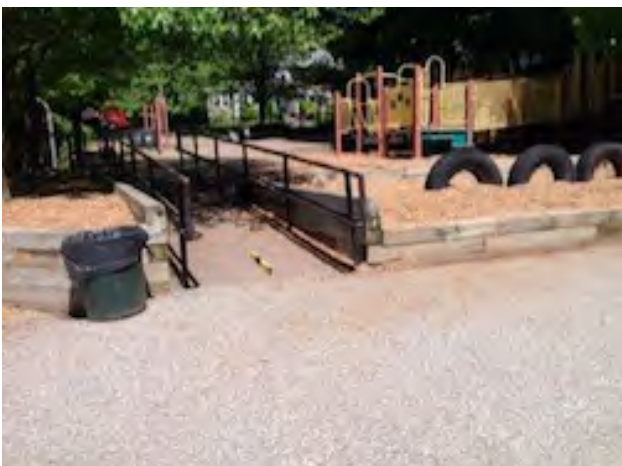
*Photo 9*

A straight ramp leading to the play areas from the school sidewalk provides a walkway that is accessible to all. This walkway connects via a hilly route to the court area below the upper playground area. (Photo 9)

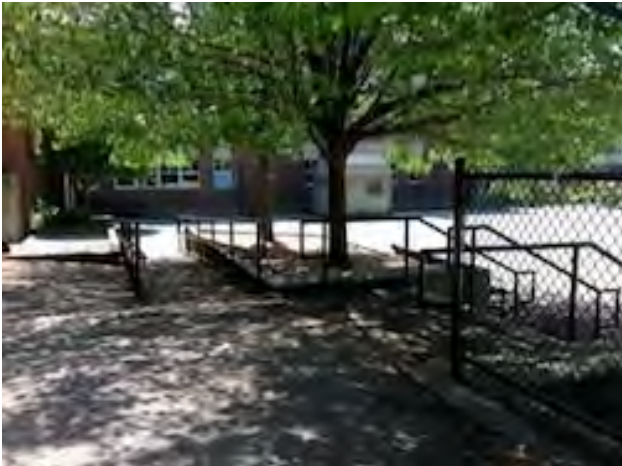
Photo 11

Stairways include accessible top handrails but lack accessible bottom handrails. (Photo 11)

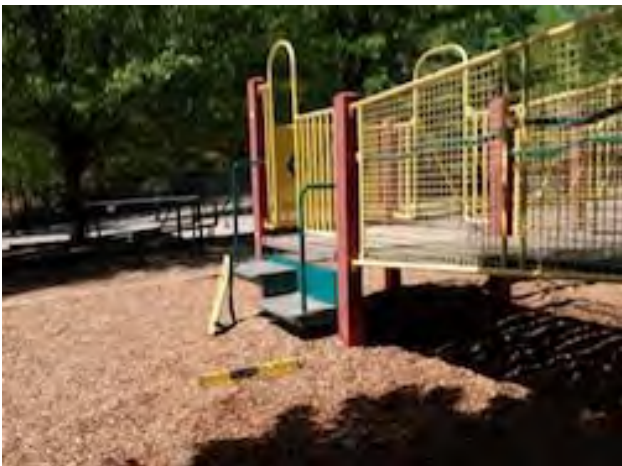
Photo 12

There are three play areas. The play area nearest Academy St. entrance includes broken swingset equipment.

Although the play areas closer to the ramp include some accessible play structures, the loose fill ground surface does not hold accessible slopes. Cross slopes are over 5% near transfer steps, and at other entry/exit points within the play areas. (Photo 12)

a. If only loose fill ground surface materials are used, a high-frequency maintenance policy needs to be in place to ensure accessibility of ground surface materials in play area use zones through all seasons.

b. If ground surface materials will be replaced: consider adding impact-attenuating tiles within the playground areas to provide accessible routes and clear ground spaces to all entry/exit points of ground play elements, including (repaired) swingsets, tires and play structure.

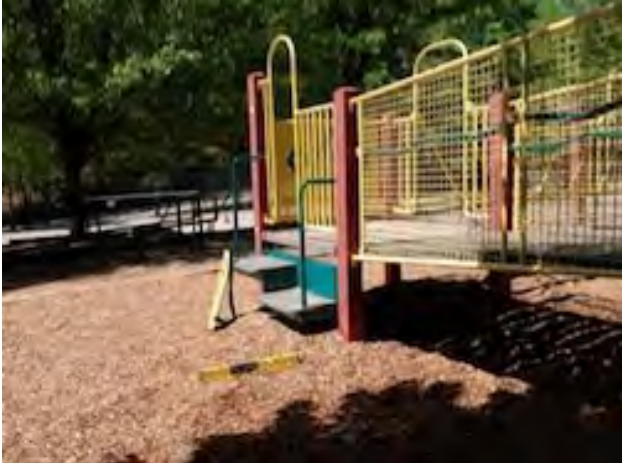
Photo 13

However, there is not an accessible (no-step) route to gain access to the accessible elevated ramp, so this is not an independently accessible feature. (Photo 13)

Although an effort was made to provide a level entry into the play area with the row of tires, the loose fill materials settle and the level entrance is not available. There can be a ramp or rubber entry provided from the surrounding walkway and an intersecting rubber tile route leading to and providing unrestricted circulation around the row of tires to provide interactive accessible play.

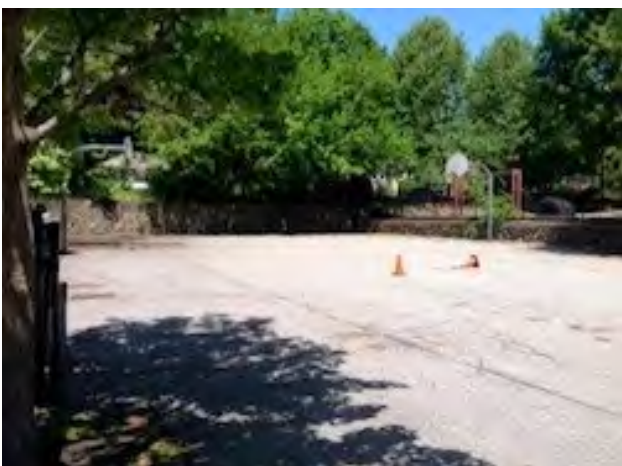
Photo 15

A full basketball court is provided at the entry gate from Irving St. This area also includes two accessible benches. (Photo 15)

The court in itself is an accessible program and area within the perimeter of site. However, the facility cannot be called accessible, because there are no accessible site arrival points to either facility entrance. (The nearby public transit routes from Pleasant @ Irving are not connected to any accessible public rights of ways, and the sidewalks leading to the Academy St. entrance have very excessive cross slopes.)

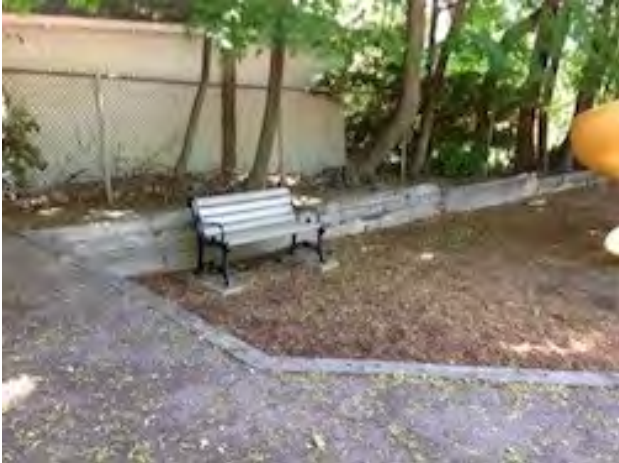
Photo 16

There is one bench at the playground area with a backrest and armrests. It is set into the recessed play area. This bench is inaccessible because it is not approached with an accessible route; and it is sitting on loose fill ground surface materials that are not holding an accessible cross slope. (Photo 16)

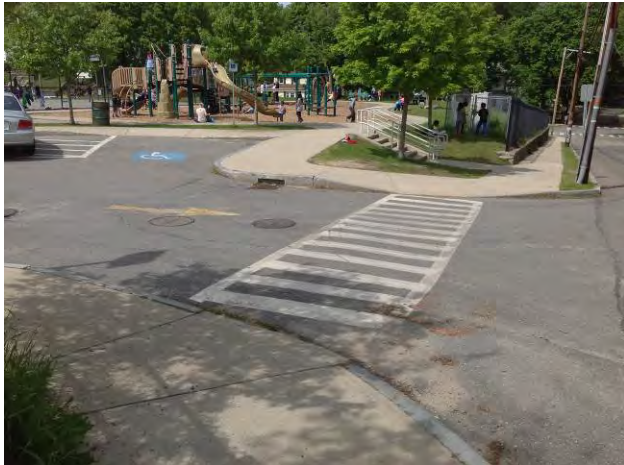
Photo 1

Sidewalks and curb ramps nearby Peirce School Park are in good condition. However, curb ramps provided on both ends of the crosswalk at the intersection of Newland Road and the driveway near the playground are not accessible because level top landings are not provided. (Photo1)

Repair both curb ramps at the intersection of Newland Road and the driveway near the playground (total of 2 curb ramps).

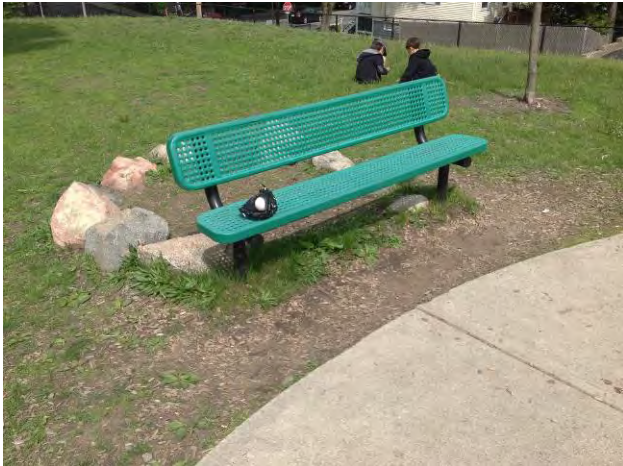
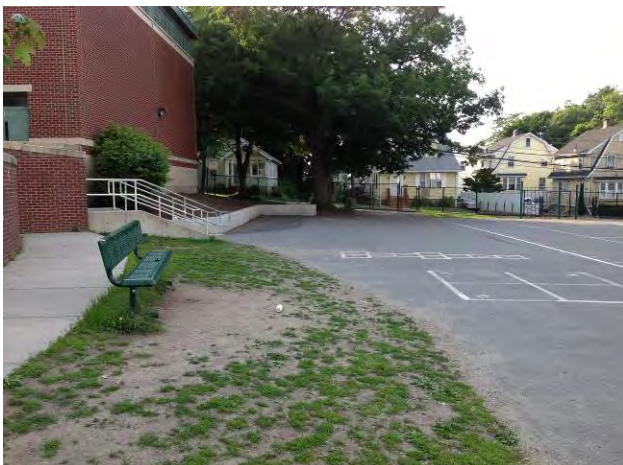
*Photo 5*

Two benches are provided along the concrete walkway near the playground and one bench is provided within the grassy area near the basketball court. Neither is accessible because they do not adjoin an accessible route. (Photos 5 and 6)

Although not a requirement under the ADA, consider providing at least 50% with armrests, as benches are replaced (total of 1 bench).

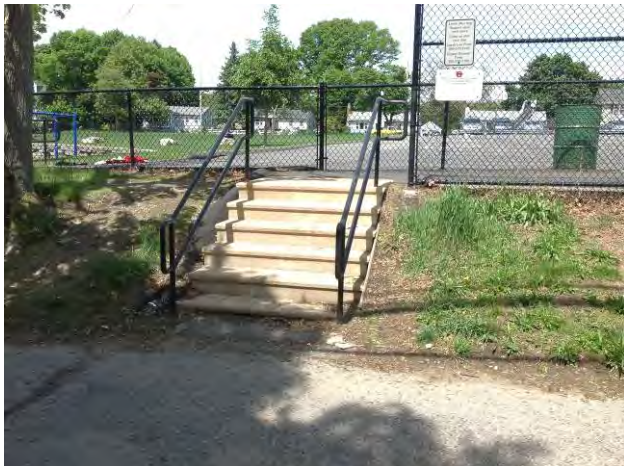
Photo 2

This facility has five points of entry: two stairways and a ramp along Pheasant Avenue and an at-grade access at the parking lot and a gate opening leading to the grassy field on Mountain Avenue. At the bottom of the stairway closest to the playground, the surface is in need of maintenance and is not slip-resistant. (Photo 2)

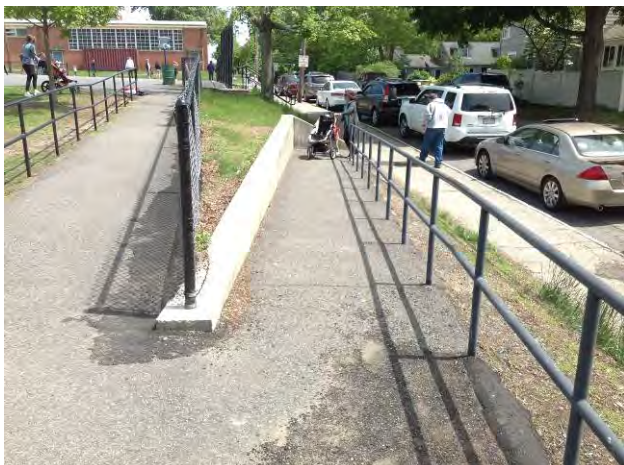
Photo 3

Twenty five feet west of the stairway, a ramp with missing railing on one side and a protective edge on the other side connects the sidewalk to the facility. Additionally, the surface at top of ramp is in need of maintenance. (Photo 3)

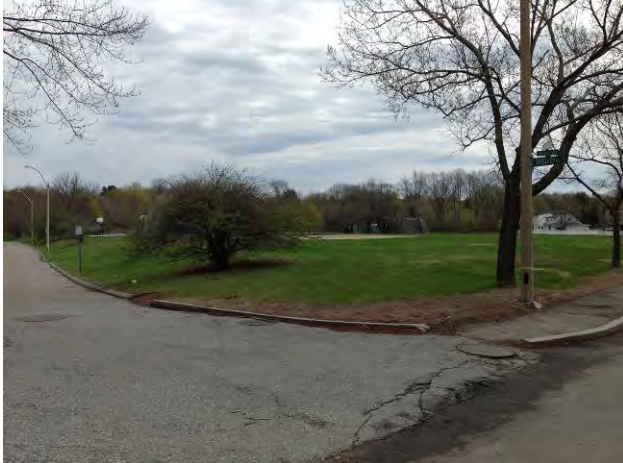
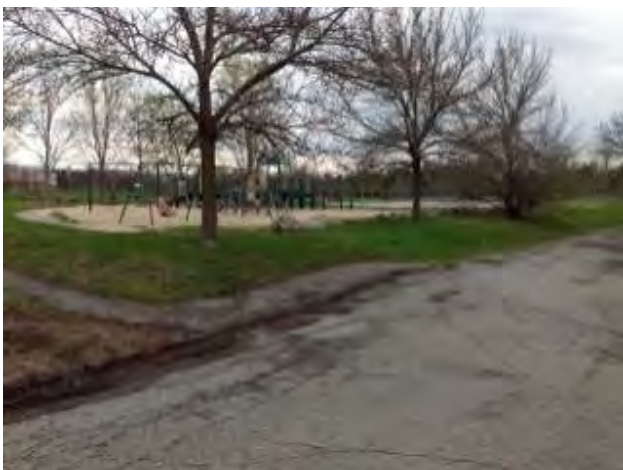
Photo 1

The sidewalk along Wadsworth Road is in poor condition. Not only are a few sections deteriorated but also the sidewalk has excessive cross slopes and sediments from adjacent areas that can make the ground surface slippery. Additionally, no sidewalk is offered along Shelley Road, except for the short section of sidewalk at the entry point near the playground. (Photos 1 and 3)

With the exception of the point of entry near the playground on Shelley Road, there are no other clear points of entry at this facility. This point of entry is in poor condition and lacks a curb ramp. (Photo 3)

Repair sidewalk along Shelley Road (about 25 feet) and extend it to the intersection of Wadsworth Road in order to create an accessible route to the nearby public transit stop (about 500 feet).

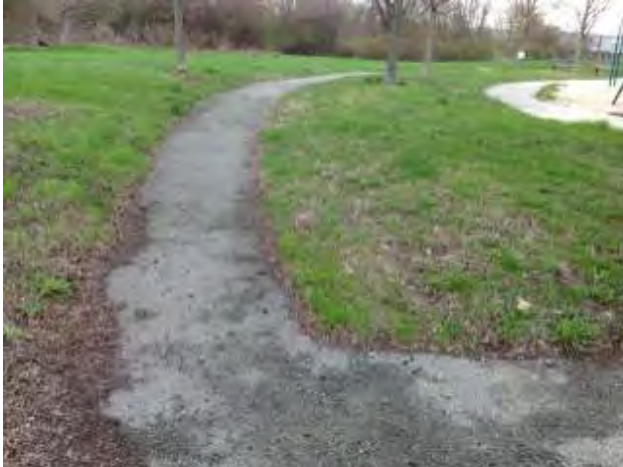
Photo 4

Although an asphalt walkway is provided between the point of entry at Shelley Road and certain features within this facility, it has excessively slopes near the street (11%) and deteriorated ground surfaces near the courts. (Photos 4 and 5)

Re-grade and repair the asphalt walkway so that it is free of tripping hazards and that running slopes are no greater than 5% and cross slopes are no greater than 2% (about 275 feet).

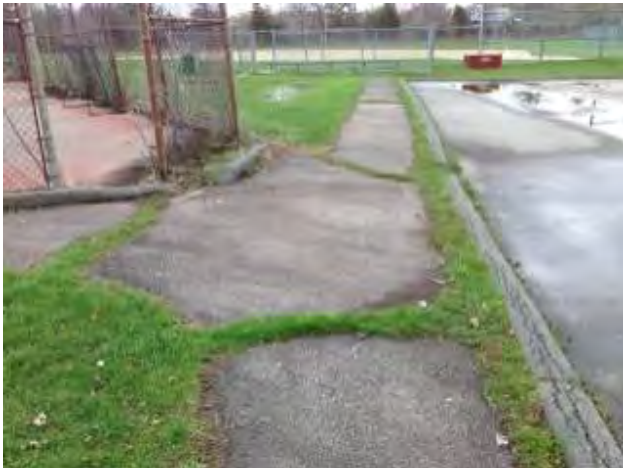
Photo 5

Because asphalt curbs are located along the perimeter of the tennis courts and the basketball court, no accessible route is provided to these courts. (Photos 5 and 6)

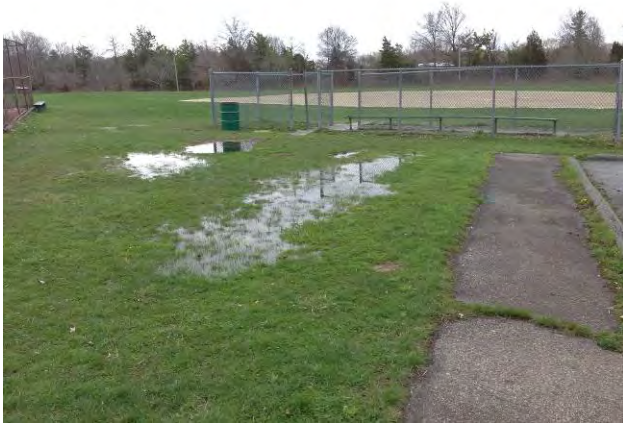
*Photo 7*

Additionally, the asphalt walkway does not extend beyond the basketball court and no accessible route is provided to the baseball field and batting cages on the South side of the facility. (Photos 7 and 8)

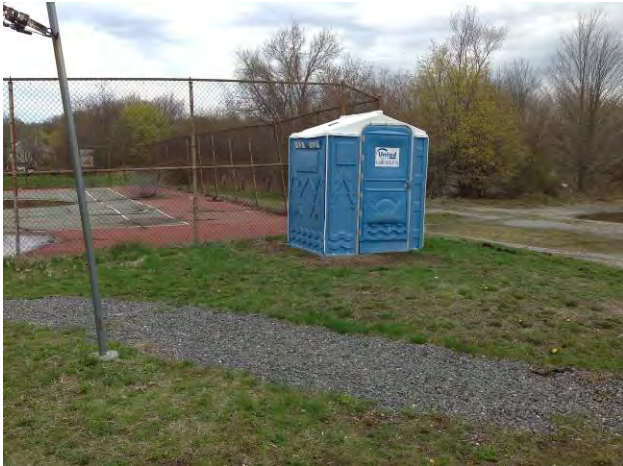
Photo 11

One portable toilet room is designated as accessible and is poorly located near the tennis courts and the batting cages. However, this amenity is not accessible because it does not adjoin an accessible route. (Photo 11)

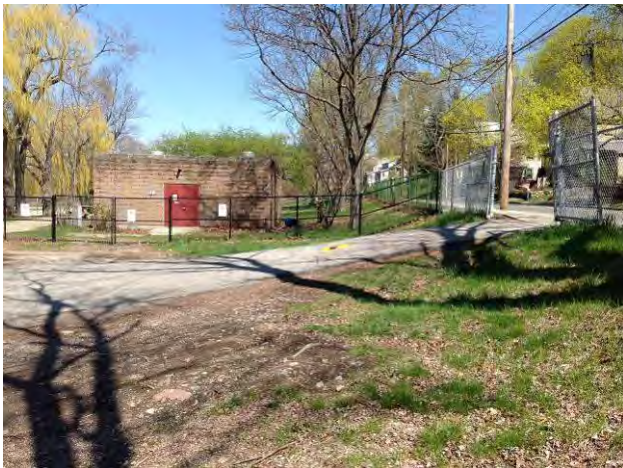
Photo 2

Along Lowell Street, both asphalt driveways that lead into this parking lot are also used for pedestrian access. The asphalt driveway closest to the beach is in poor condition and has excessive slopes (20%). (Photos 2 and 3)

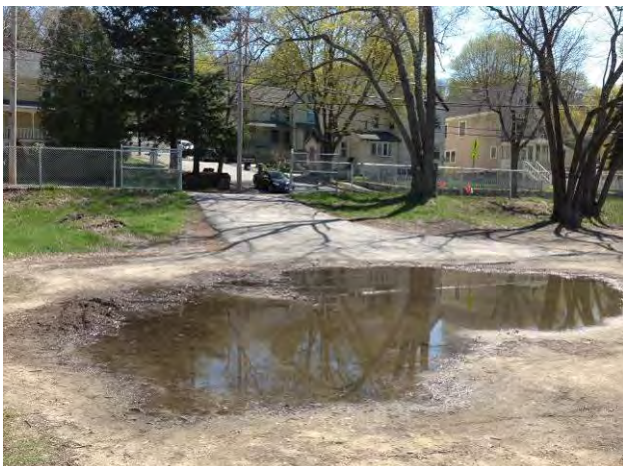
Photo 3

This facility has a large unpaved parking lot off of Lowell Street. Although two *ad hoc* spaces designated as accessible are provided near the gated entrance to the beach, they do not meet any of the minimum requirements for accessibility. (Photo 3)

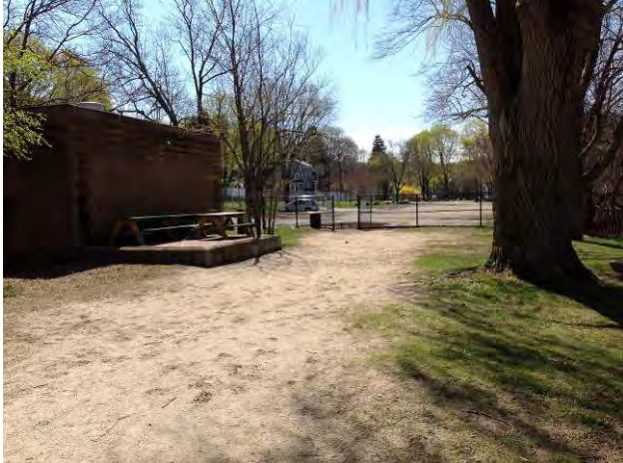
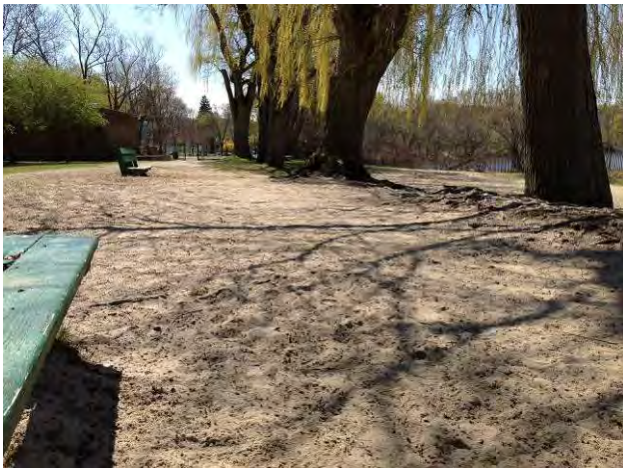
Photo 4

A sand path is provided along the entire facility. This path is not accessible because it is uneven and unstable, especially near benches and trees. Although a concrete walkway is provided near the water's edge, it is not connected to an accessible route. (Photos 4 and 5)

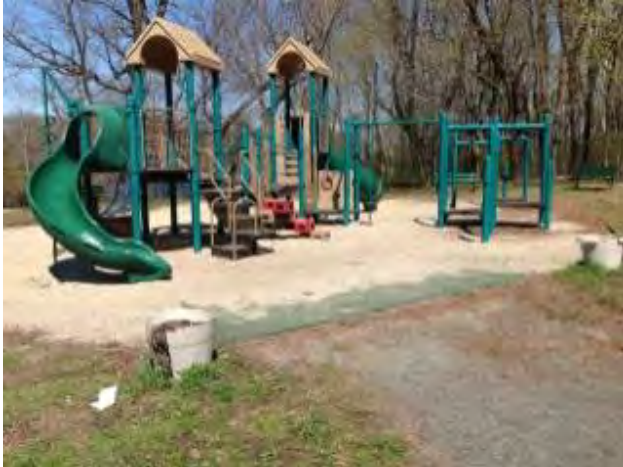
Photo 7

One large sandy area contains three separate zones of play structures. Although an accessible route is provided to the large play structure, the transition between stone path and rubber surface is in poor condition. (Photo 7)

Repair the transition between stone path and rubber surface at the large play structure and install an accessible walkway between points of entry and the swingset and the small play structure. The accessible route to these play areas can adjoin the new accessible walkway through the facility.

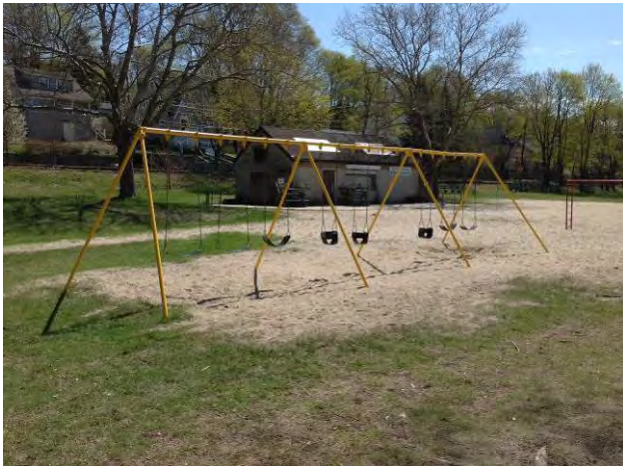
Photo 8

No accessible route is provided to the swingset and the small play structure. (Photos 8 and 9)

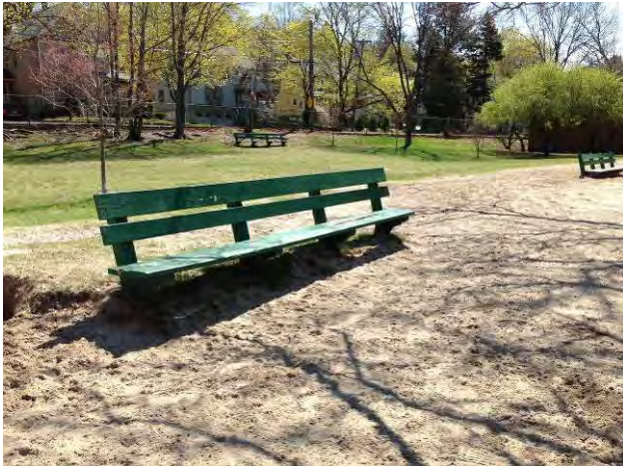
Photo 11

Several benches are provided through this facility. They can be found along the sand path and trees, within the grassy knoll near the fence on Lowell Street, within the playground, and near the water's edge. The benches are not accessible because they do not adjoin an accessible route. (Photo 11, next page)

Although not a requirement under the ADA, consider providing at least 50% with armrests, as benches are replaced (total of 10 benches).

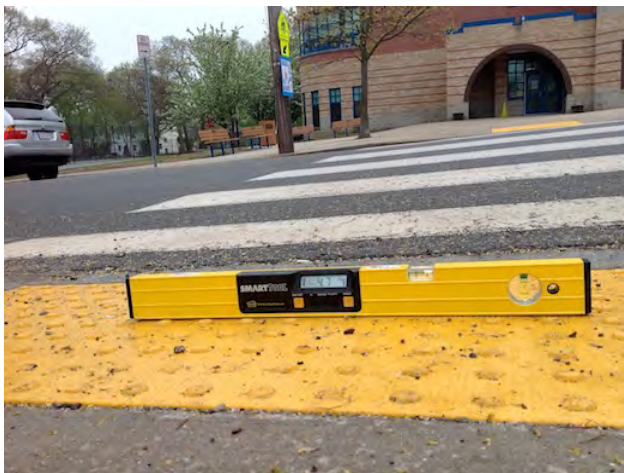
Photo 2

New curb ramps with tactile strips are provided at crosswalk between school entrance and 1 park entrance. Both curb ramps have noncompliant cross slopes and excessive level changes at bottom. (Photo 2)

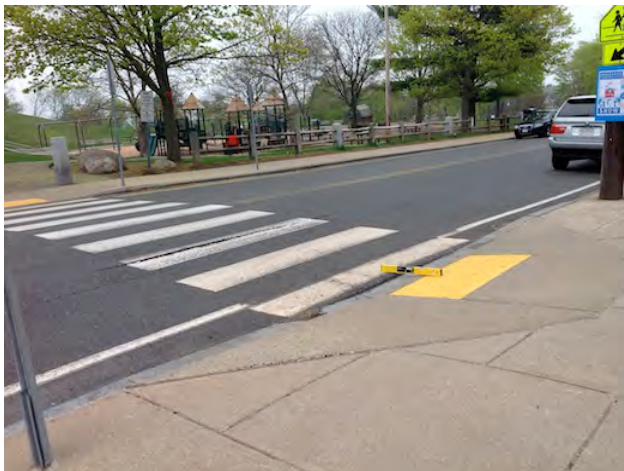
Photo 3

The curb ramp on school side of crosswalk also has a noncompliant run slope and an excessive vertical depression at the gutter to ramp transition, leading to water and ice accumulation issues. (Photo 3)

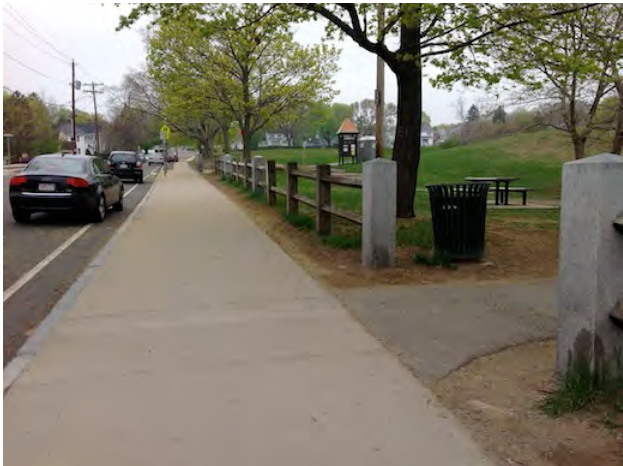
Photo 5

There are 2 points of entry along Eastern Avenue within 100 feet of each other. Neither entry point leads to an accessible walkway that links all areas, elements and amenities within the perimeter of site along a unified route. (Photo 5)

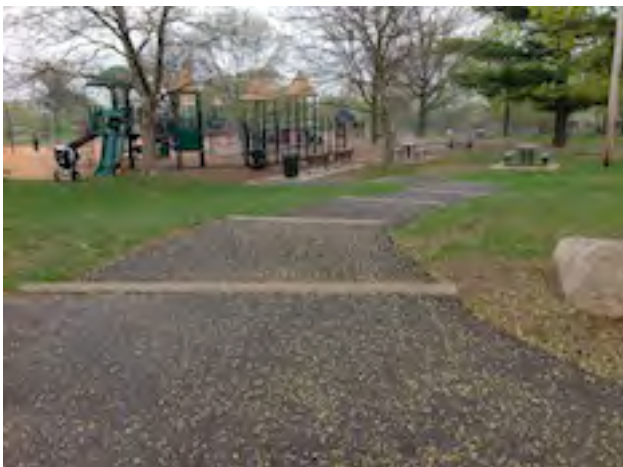
Photo 6

The only interior connection between these 2 entry walkways is an inaccessible wide tiered stairs route with *no* handrails. (Photo 6)

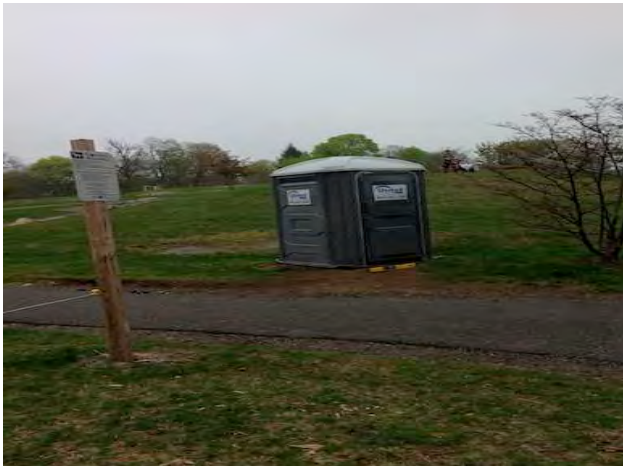
Photo 8

The walkway extending from the school crosswalk entrance provides an at-grade entrance and access to the Long Hill Slide/staircase top and the Boston Skyline Viewing Oval. This route has some cross and run slope issues that can be mitigated with small wall or handrail supports. This walkway does not connect to the border of field sports activities, the 2 sides of the court, the benches on Baseball Hill, or the portable toilet entrance. (Photo 8)

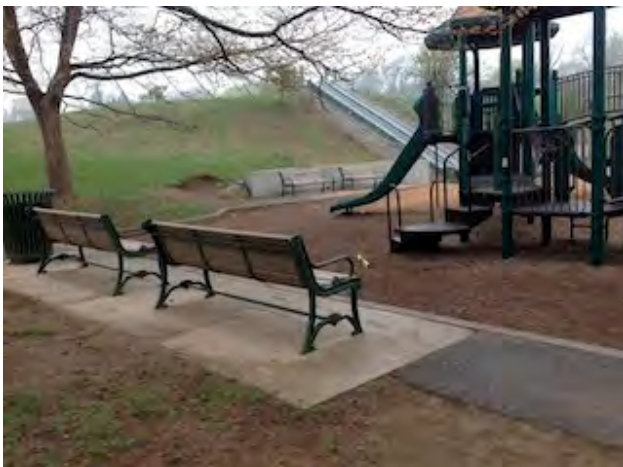
Photo 9

Although the walkway from the entrance west of the school crosswalk leads to the play areas and benches, it does not provide an accessible connection because of level changes and lack of clear width. (Photo 9)

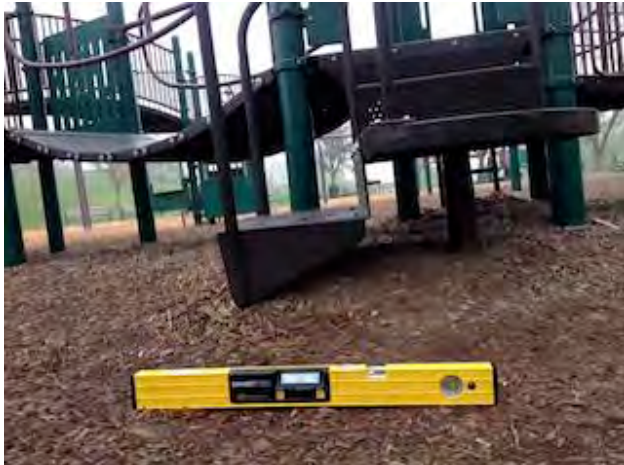
Photo 10

The bordered playground is surfaced with loose-fill ground surface materials.

The vertical borders on both sides of walkway and along entire perimeter of play areas do not include an accessible entry/exit ramp or firm leveled surface into play areas.

Loose-fill surface materials require frequent maintenance to ensure accessibility in all seasons. These play areas do not currently offer accessible circulation routes because the ground surface materials have excessive cross slopes, depressions, and protrusions near and within ground play elements and transfer stations. (Photo 10)

a. If only loose fill ground surface materials are used, implement a high-frequency maintenance program to ensure accessibility of ground surface materials through all seasons.

b. If ground surface materials will be replaced: consider adding unitary surface materials within the playground areas to provide accessible routes and clear ground spaces to all entry/exit points of ground play elements, including swingsets, play structure transfer station, and ground play elements.

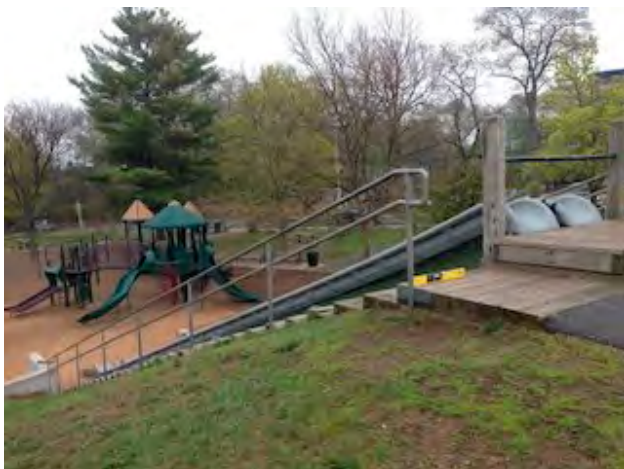
Photo 11

The recessed playground area is the exit point for the Long Hill slides and accommodates 2 play areas that are age-appropriate. There is no accessible connecting route between the bottom and the top of the slide. (Photo 11)

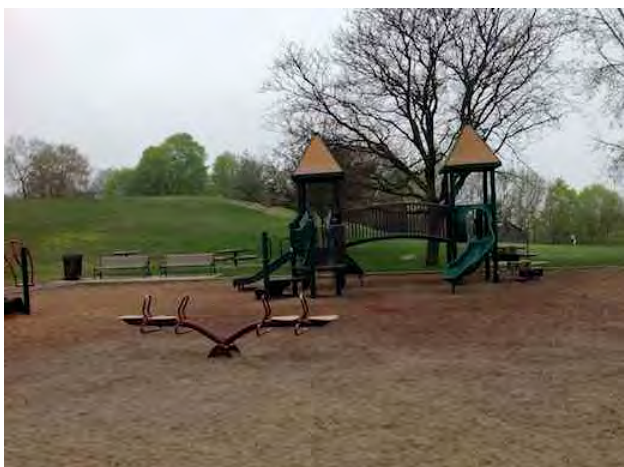
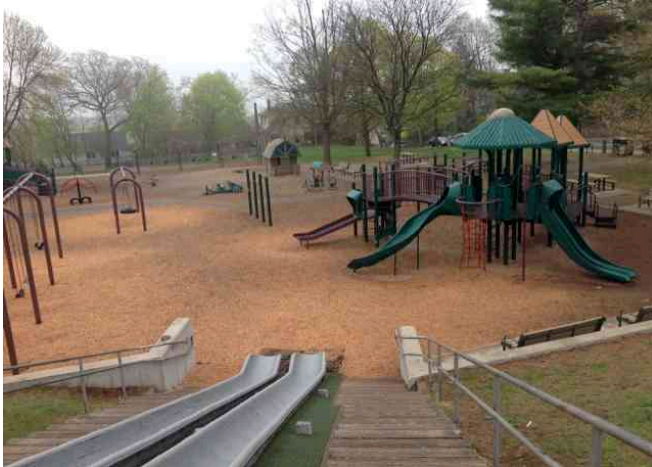
Photo 12

The play structure for younger children has an exceedingly steep ramp that does not provide accessible use of elevated play components. Although there are a unique variety of free-standing ground play elements, including 2 wooden cars, 1 small cabin, a See-Saw, Multi-Pondo, and a sandbox; and, the play structure also offers 3 types of ground play elements, these elements are not accessible because the ground surface materials are not accessible and there are no accessible entry points into play areas. (Photo 12)

The composite play structure for older children does not include an accessible elevated route. The transfer steps do not lead to at least 51% of different types of elevated play features. There are 8-13 inaccessible play features for older children, including the Long Slide, which is not connected to an accessible route from bottom to top. There are not a proportionate number of accessible ground or elevated play elements for children with disabilities, age 5 and older. (Photo 12)

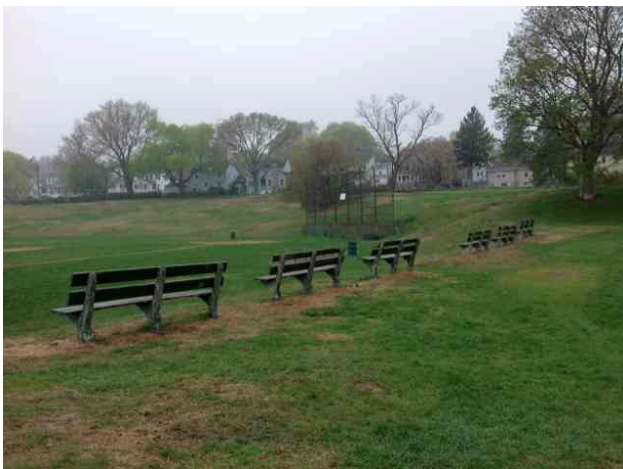
Photo 14

The soccer and ball fields are not located along an accessible route. Run slopes near benches indicate that an accessible route with handrails is feasible. (Photo 14)

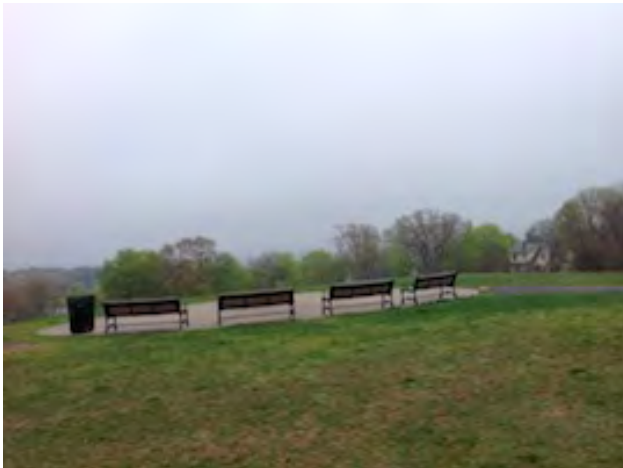
Photo 16

The Viewing Oval is connected to one interior walkway; and there is a level, firm and smooth clear space available to be used for integrated wheelchair seating. (Photo 16)

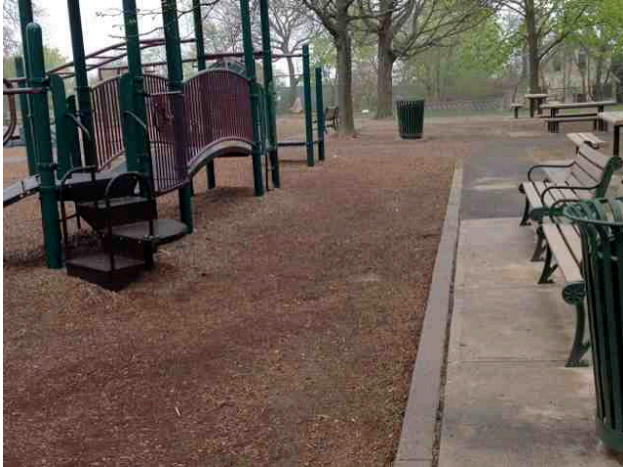
Photo 18

Benches are not connected along an accessible route due to lack of minimal maneuvering width from walkway; the vertical level changes of the walkway and playground perimeter borders; and the lack of a firm, level ground surface inside play areas. (Photo 18)

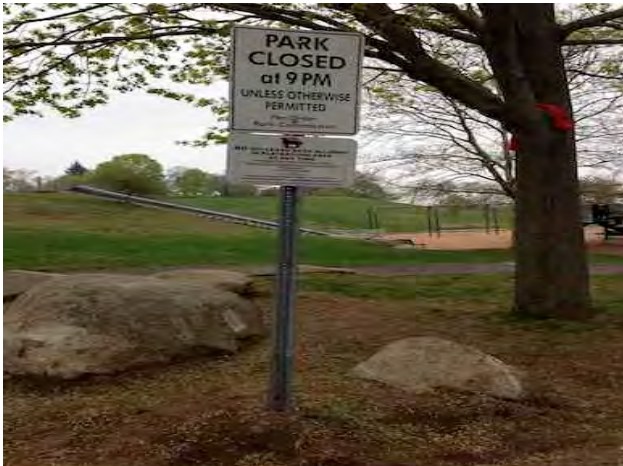
Photo 19

Signage denoting Dog Walk Hours and rules are posted too high proportionate to the approach and viewing distance provided along the trails. (Photo 19)

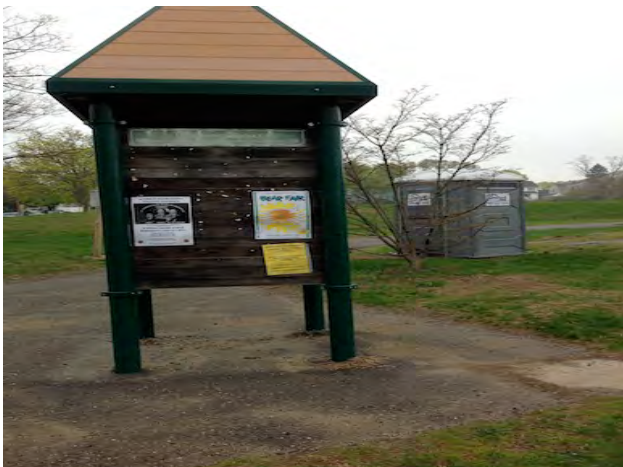
Photo 20

The information kiosk/bulletin board at the crosswalk entry point includes health information about Lyme disease that is mounted above 60 inches from the ground and cannot be read because the font is too small. (Photo 20)

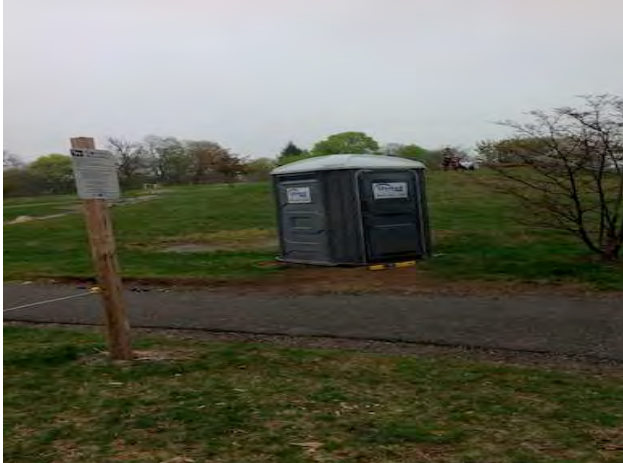
Photo 21

Rental of portable toilets began in 2012. This is an accessible portable bathroom; however, it is not located along an accessible route. The route from the walkway to the door is dirt mixed with gravel and is steep, not slip-free, not firm and not level. (Photo 21)

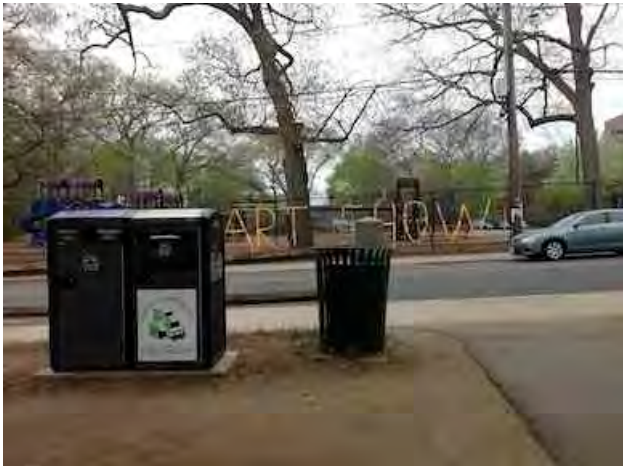
Photo 22

The recycling compactor is not located along an accessible route and is located on a platform, which does not provide accessible reach ranges or accessible clear space for forward and parallel approach. (Photo 22)
